Addendum to Environmental Impact Assessment

India: Assam Power Sector Investment Program - Tranche 3

120 MW Lower Kopili Hydroelectric Project

Addendum to the Environmental Impact Assessment (Updated)

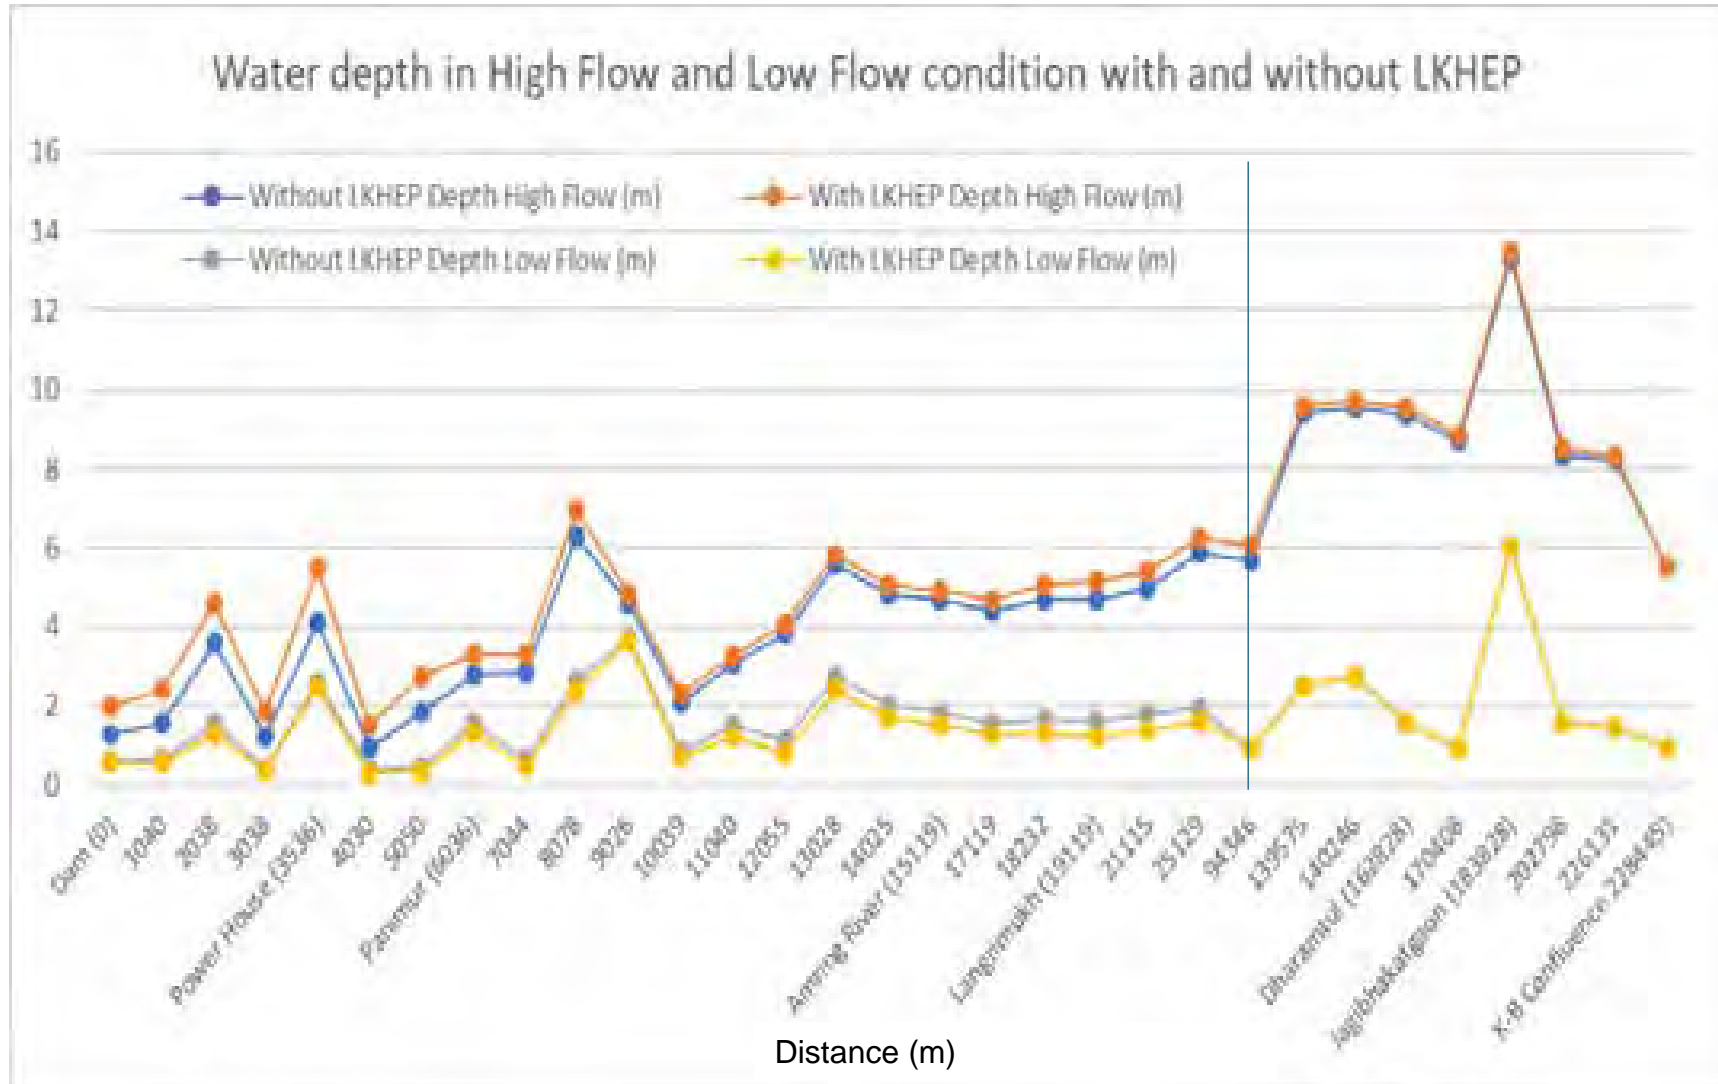
Figure 2: Pre and Post LKHEP water depth (M) in low and high Flow Events

23. Influence of water level has been observed up to around 95 Km downstream from the LKHEP Dam (Figure 2). After that point there is no significant change in the water level. Low flow events after LKHEP varied between 0.03 m to 0.45 m in different sections of the river. Similarly, during monsoon, the water level will increase by 0.03 m to 1.5 m. Major changes are observed in the Dam to the confluence of the Amring River only. So downstream of LKHEP has been considered upto 95 Km. Influence of Brahmaputra water level can be seen upto around 139.2 km downstream from the dam (near the confluence of Kolang river).

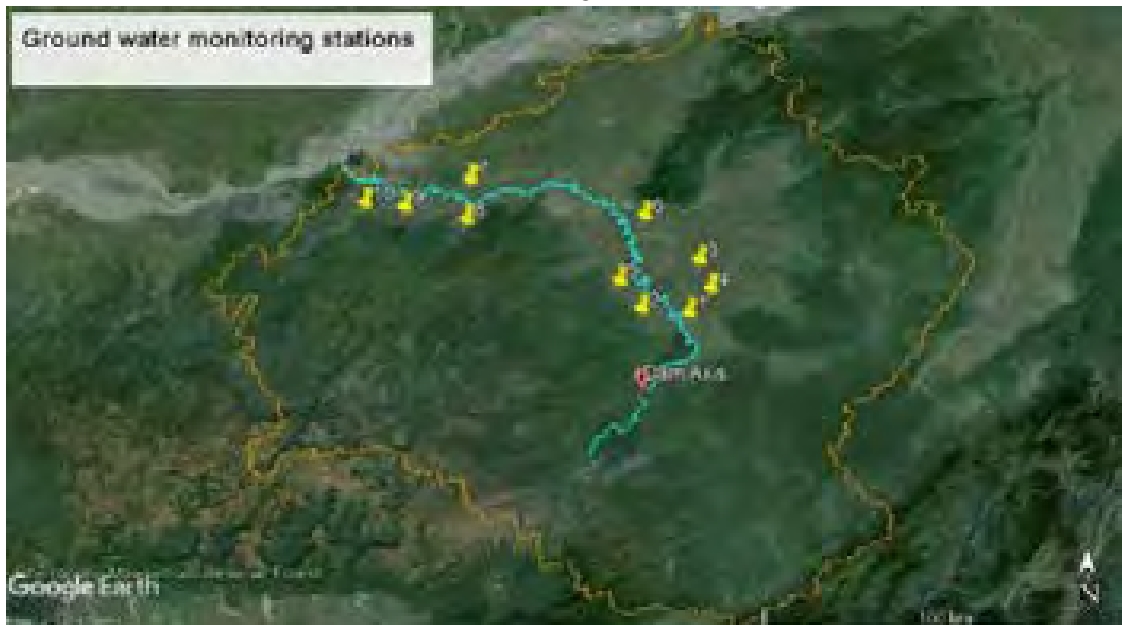
Figure 5: Ground water Monitoring stations maintained by CGWA near Kopili River

35. To know the impact of the reservoirs on the ground water level in the downstream, water level parameters of the 10 monitoring wells maintained by CGWA were analysed for all the seasons (Figure 5). There was no significant change in the ground water level over the years. As Jagiroad station has longest series of data set, hence the results of that station for each season are presented in the Figure 6 and variation of water level throughout the year are shown in Figure 7.

37. There is no change in ground water level downstream from the Kopili HEP observed based on the long term historical data and it is also expected that similar trend might prevail after operation of Lower Kopili Hydro Electric Project at Longku, Dima Hasao. .

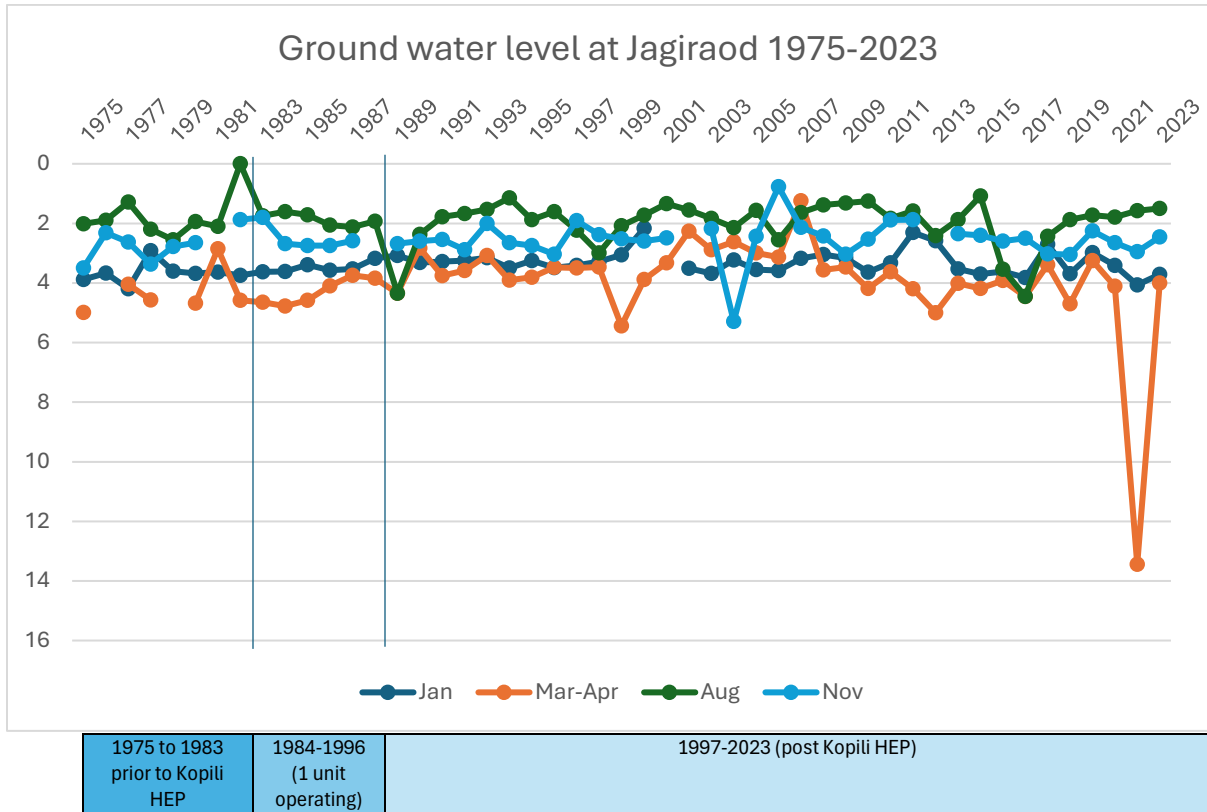
Figure 7: Seasonal Variation of Ground water at Jagiraod CGWA well

1975 to 1983 prior to Kopili HEP	1984-1996 (1 unit operating)	1997-2023 (post Kopili HEP)
----------------------------------	------------------------------	-----------------------------

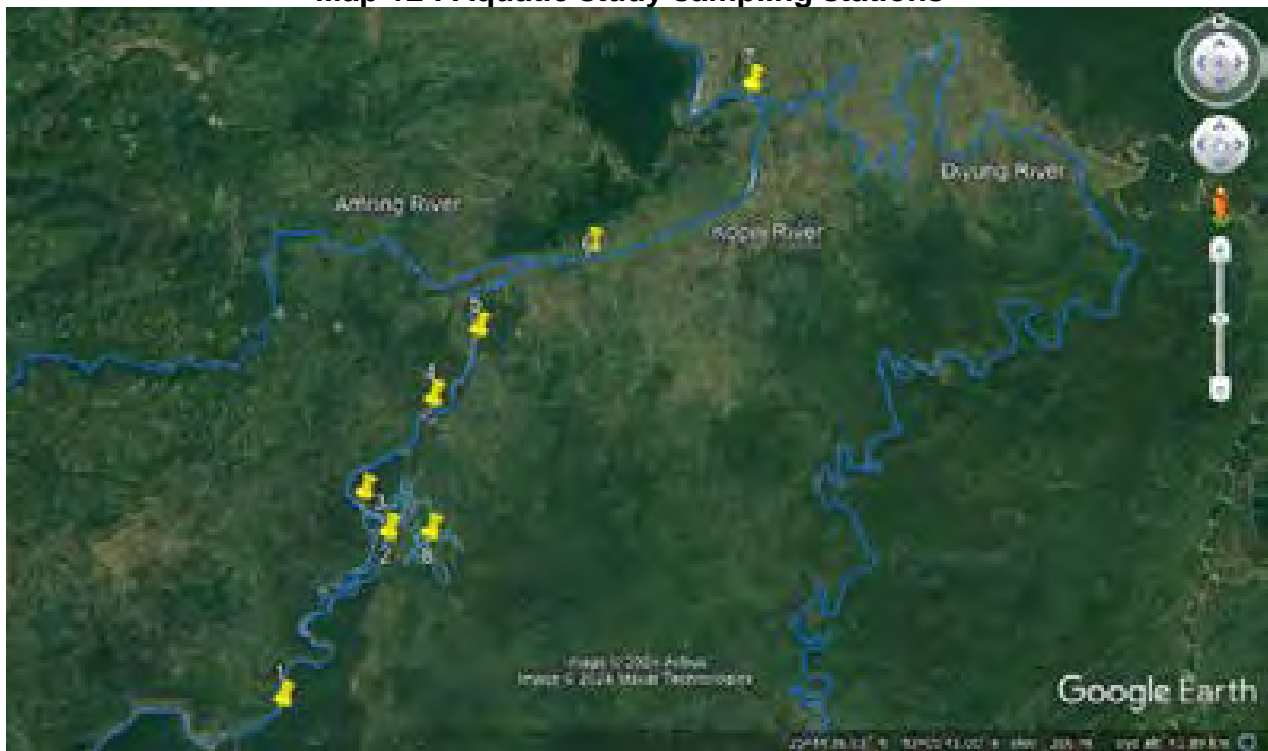
Map 12 : Aquatic study sampling stations

Station 8: Reservoir area on Longku Nala (Pond created due to one dyke) (Map 12)

To ascertain the magnitude of the impact on biotic and abiotic components during water releases in various seasons and during peaking power generation, thorough assessments are necessary. As per the amendment of the Environment Clearance on 3rd Jan 2024, MoEF&CC has stipulated additional condition for Aquatic study specially, migratory aquatic species concerning occurrence of fishes /habitat impact studies shall be carried out from recognised govt. Institutes and to prepared mitigation measures, with provision of financial budget revised in the EMP. APGCL engaged the College of Fisheries, Raha under Assam Agriculture University to carry out the study. As per the requirement 8 samplings were carried out during the period February to May 2024. Findings are described based on the study carried out during this period only and samples were collected from 8 nos. of sampling stations u/s and d/s of the LKHEP dam up to the confluence of the Diyung river.

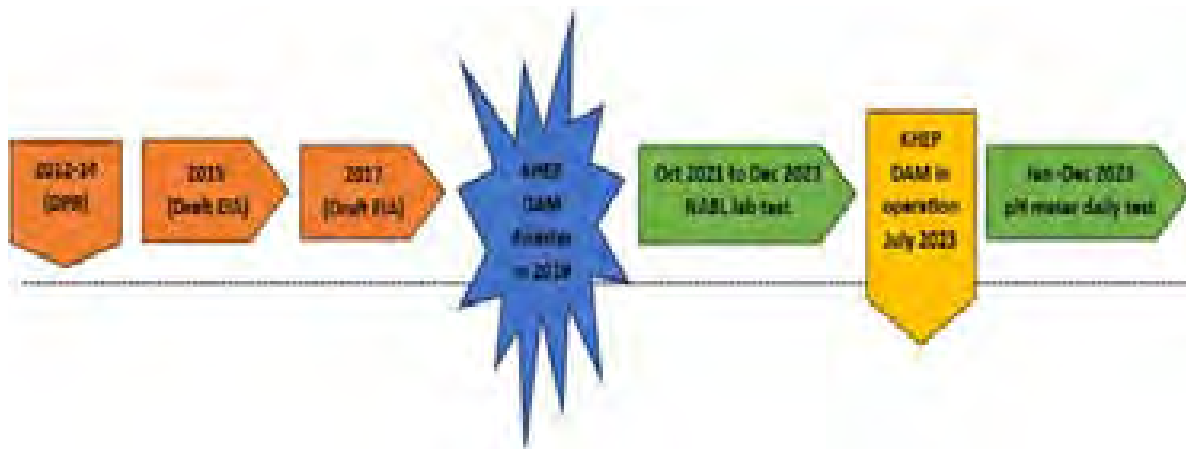
Figure 8 : Testing the pH of Kopili River

43. Below the chronological order of Kopili river sampling and testing under this project has been presented.

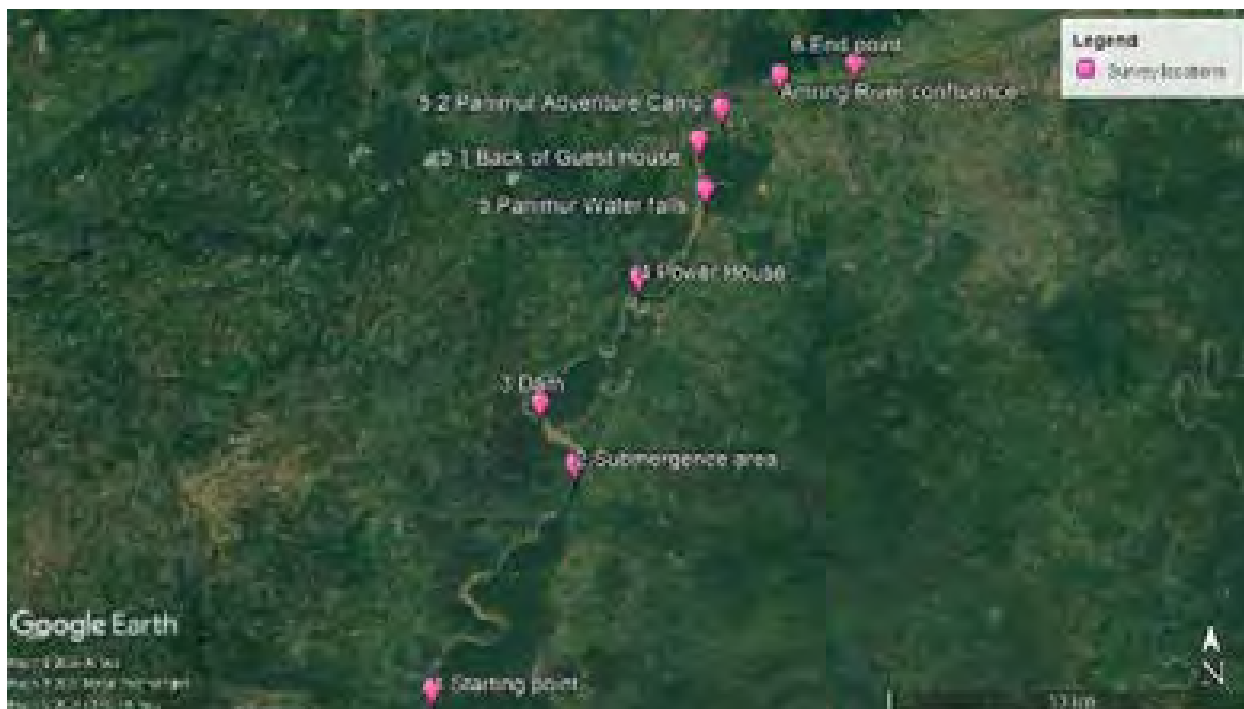
Map 20: Sampling Locations for rheophytes

142. Around 13.6 Kilometer upstream and 15.9 Kilometer downstream of the LKHEP dam has been surveyed on 5th to 6th April and 15th to 18th April 2024 (Map 20). Flowering season was selected. Flowering of *C. kopilii* and *S. nivae* is from August – October, hence survey is also proposed in August -October, 2024. Sampling stations are mentioned in Map 20.

144. Distribution maps of rheophytes of Kopili river in Dima Hasao and West Karbi Anglong districts in Assam were done using georeferenced photographs, consultation of available literature and field surveys.

145. Rheophytes were not found in the sampling station No.1 and 6 (Map 20). All the patches were visited either directly (on the right bank) or by boat on the islands or on the left bank. Two seniors botanists were engaged including one of the authors who described the species from the site for the first time. The distribution polygons were delineated based on the ground distribution of all the rheophytes using GPS. Map 21 to Map 26 shows the distribution of rheophyte plants in Kopili river.

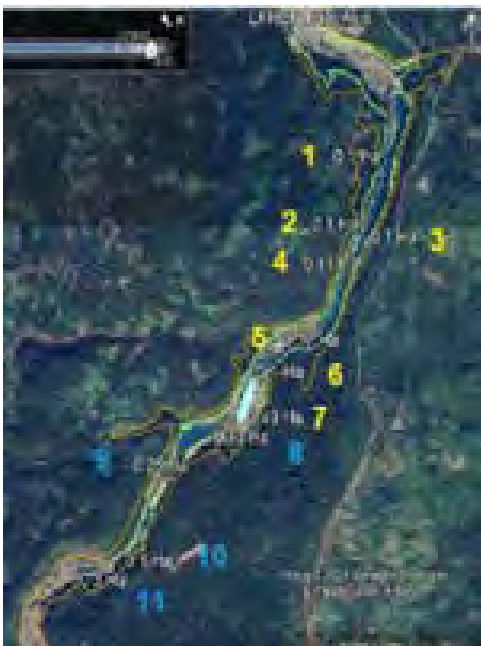
Table 17: Distribution of the rheophytes in submergence area and their inundation as per Rule curve

Patch No from DAM	Size of the patches (Ha)	Important Species	Month	Water level of the reservoir (m) amsl																						
				205	206	207	208	209	210	211	212	213	214	215	216	217	218	219	220	221	222	223	224	225	FRL	226
1	0.1	<i>Syzygium cyanophyllum</i>	Jan																							
2	0.1	<i>Syzygium cyanophyllum</i>	Feb																							
3	0.1	Species confirmation will be done after the detail survey	Mar																							
4	0.11		Apr																							
5	0.17		May																							
6	0.1		June																							
7	2.49		July																							
8	0.13		Aug																							
9	0.25		Sept																							
10	0.1		Oct																							
11	0.3		Nov																							
			Dec

3.95		Total																							
	Percentage of total inundation of the patched with Rheophytes at different water level			8-11	8-11	8-11	8-11	8-11	8-11	8-11	8-11	8-11	8-11	8-11	8-11	8-11	8-11	8-11	8-11	8-11	8-11	8-11	8-11	8-11	8-11	8-11
	Partial innundation of the patch number			80.25	80.25	85.00	85.00	90.00	90.00	95.00	100.00	100.00	100.00	100.00	100.00	100.00	100.00	100.00	100.00	100.00	100.00	100.00	100.00	100.00	100.00	100.00

160. As per the Rule curve parts of the rheophytic plants in 4 patches in the upstream will be above water from February to June. But rest 7 patches will be under water throughout the year (Table 17). Species confirmation in the patches numbered 8 to 11 will be crucial for preparation of the conservation management plan for *Syzygium cyanophyllum*

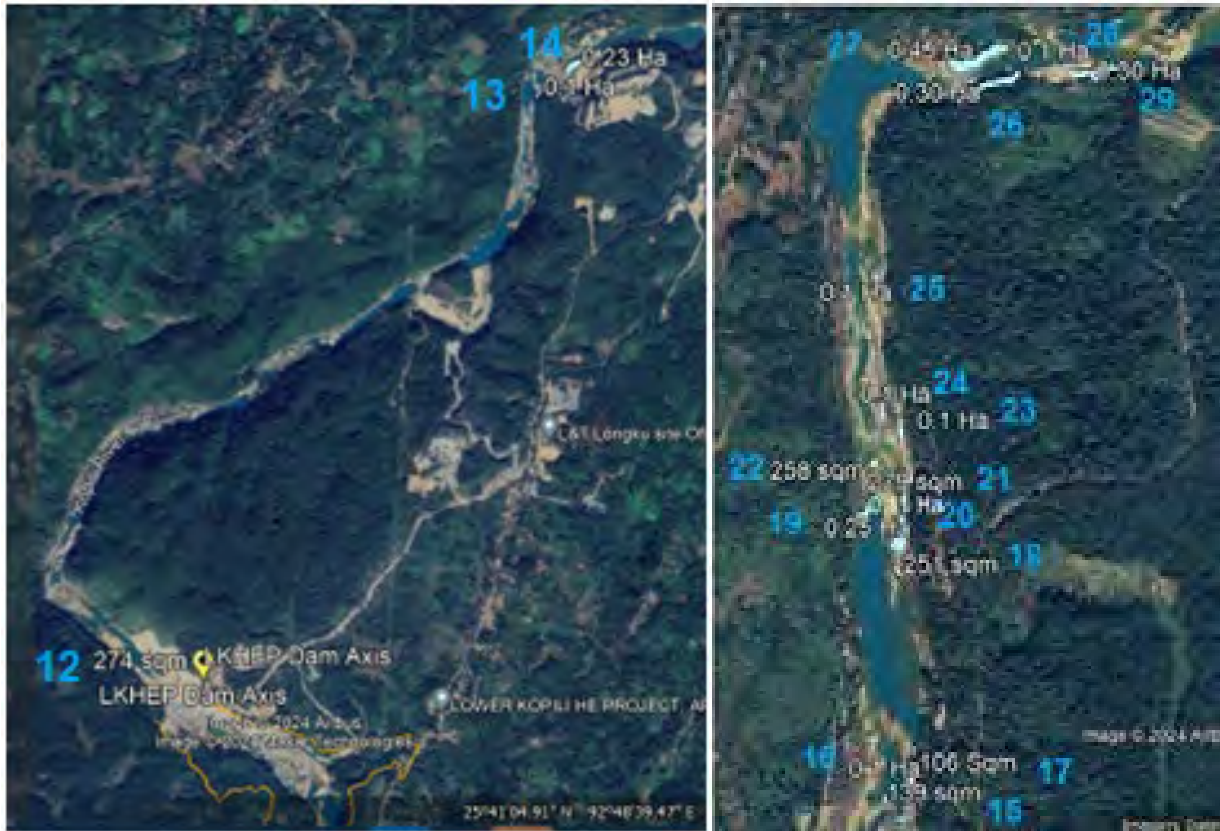
Table 19: Distribution of the Rheophytes in the downstream and their inundation during different season.

Patch No from DAM (D/s)	Size of the patches (Ha and sqm)	Size of the patches (Ha)	Height of the plants (m)	Important Species	HFL	Without LKHEP				Highest water level during operation (m)	After LKHEP			
						Velocity (m/s)	Inundation of area during different seasons (in %)				Velocity (m/s)	Inundation of area during different seasons (in %)		
						Monsoon	Non Monsoon	Non Lean	Lean		Monsoon	Non Monsoon	Non Lean	Lean
Dam to Power House (TRC)					Dam at 90 m d/s 185.987 m	June to Sept	Apr, May, Oct, Nov		Dec to Mar		June to Sept	Apr, May, Oct, Nov		Dec to Mar
12	274 sqm	0.027	1	<i>Carissa kopilii</i>		0.2-0.3	100	40	10		100	40	8	
			2	<i>Syzygium cyanophyllum</i>		0.2-0.3	100	40	10		100	40	8

12.1	137 sqm	0.014	1	<i>Carissa kopilii</i>		0.2-0.3	100	40	10		100	40	8	
			1	<i>Syzygium cyanophyllum</i>		0.2-0.3	100	40	10		100	40	8	
13	0.1	0.1	1	<i>Carissa kopilii</i>		0.3-0.89	70	30	0		75	25	0	
14	0.23	0.23		Species to be identified during Detail survey		0.3-0.89	100	40	0		75	25	0	
15	139 sqm	0.014				0.3-0.89	50	10	0		60	15	0	
Power House to Amring River					118.715 m	0.6				104; during Flood 111.66	3.864 (end of TRC)			
16	0.1	0.1				0.23-0.87	50	10	0		60	15	0	
17	106 sqm	0.011		Species to be identified during Detail survey		0.23-0.87	50	10	0		60	15	0	
18	251 sqm	0.025				0.23-0.87	50	10	0		60	15	0	
19	0.25	0.25	1	<i>Carissa kopilii</i>			50	10	0		60	15	0	
20	0.11	0.11					50	10	0		60	15	0	
21	279 sqm	0.028					50	10	0		60	15	0	
22	258 sqm	0.026		Species to be identified during Detail survey			90	10	0		95	15	0	
23	0.1	0.1					70	10	0		70	10	0	
24	0.1	0.1					30	5	0		40	8	0	
25	0.1	0.1					30	5	0		40	8	0

163. Some inundation is expected from the dam to the powerhouse that is the dewatered section and will be served by the e-flow. Water velocity coming out of the auxiliary powerhouse can be higher than normal but is expected to get dissipated due to the plunge pool. Section from powerhouse towards downstream is anticipated to face the impacts of inundation and velocity to a greater extent. Based on the position of rheophytes on the maps, inundation is expected to be minimal (Table - 19).

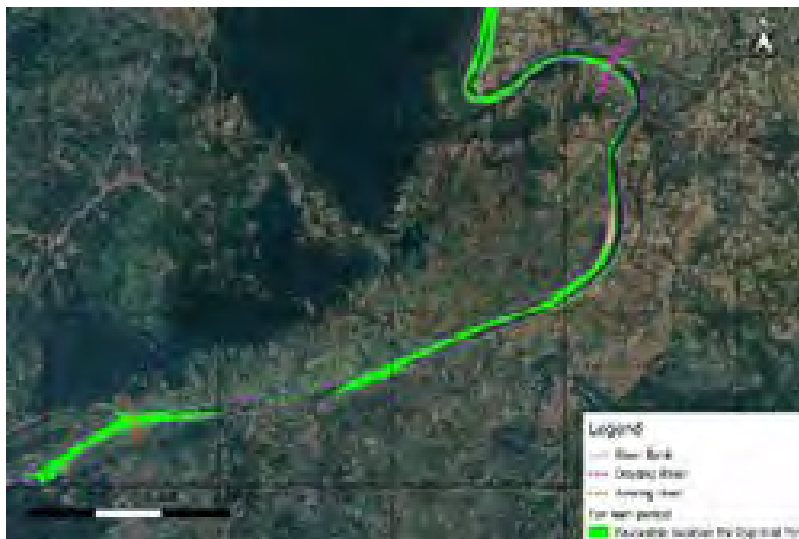
Lean Period

Map 36: Suitable Habitat for Cyprinid during lean period (Confluence of Amring river to Confluence of Diyung river)

196. Cyprinids are the only species which shows limited migration in the river as per the literature. Considering the minimum requirement of water depth and velocity of *Tor tor* (endangered Cyprinid species) required for migration during both adult and juvenile stage, the following suitable habitats were identified in the d/s of the river Kopili. Adults of the golden mahseer (*Tor putitora*, the studied species) were mostly found in deep waters (> 2 m) with cool temperature (18-23°C) and low water velocity (0-0.4m/s). Low water velocity are preferred by the adult cyprinid species. Fingerlings were mostly seen at depth ranges (0.1-0.6m) with velocity (0-1.2m/s) where dominant substratum was gravel and sand. Similarly, depth range between (0.3-1.8m), moderate velocity (0.3 -1.2m/s) and habitats with cobbles, bed rock and gravel as substrate were used by the juveniles. (Source: Johnson et al., 2017⁵⁵).

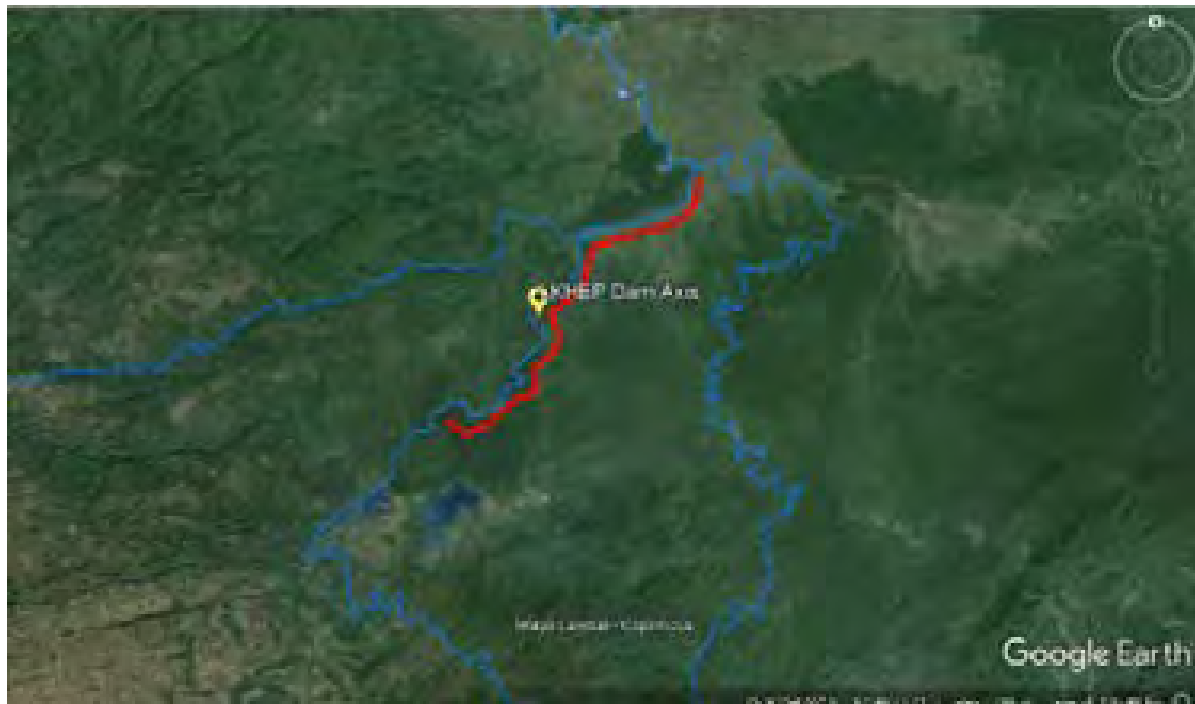
Map 37: Impact (Red Line) and Non-Impact Zone of the study stretch of River Kopili

203. In the aquatic ecosystem, interaction occurs between biotic and abiotic factors are prevalent, Abiotic factors comprising physical and chemical components which has create an adverse effect on the aquatic community in their growth, abundance, community structures and distribution patterns etc. in a river ecosystem. To evaluate the potential impact of water of a river, ecological parameters like phytoplankton, zooplankton and fishes are the key tools for understanding Based on the population dynamics and distribution patterns, it is easier to identify the impact zone of a river stretch. Based on the 4 months data (Physical, chemical and biological parameters) of the present investigation. Station 7 i.e. post confluence of River Diyung and Kopili, can be regarded as non-impact zone. In the impact zone of the study stretch of river Kopili i.e. from station 1 to 6, (Map 38) many of the critical water quality parameters (pH, Total Hardness and Total Alkalinity) were found to be not congenial for aquatic life as a result of which no fishes, plankton and periphyton were recorded in this zone. However, in the station 7 after dilution of Kopili River water by River Diyung, the parameters were found to be suitable for aquatic organisms (Map 37). During the present study in the non-impact zone, we have recorded 16 fish species, 19 phytoplankton Genera and 5 zooplanktonic forms. Water level fluctuation from Dam to Diyung river during operation of the plant is shown in the figure 2. Graphical representation of the impact zone and non-impact zone is shown in the Figure 47. These impacts are due to existing water quality issues and this is the environmental baseline describing the existing environment prior to project implementation.

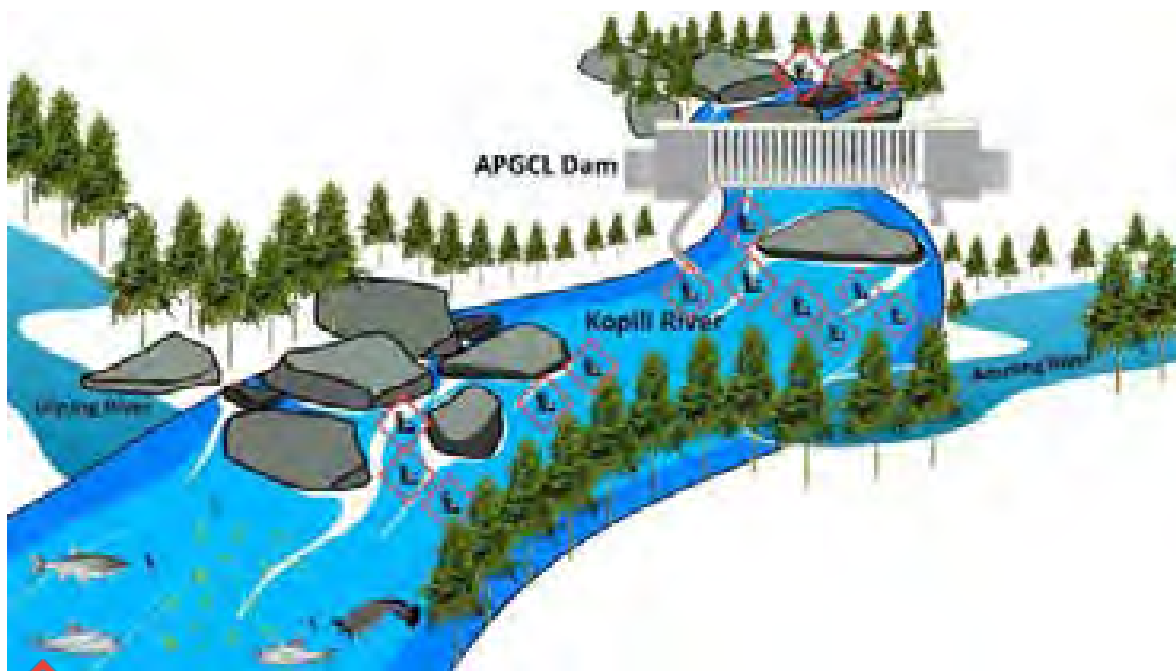
Figure 47: Impact and Non-Impact Zone of River Kopili with Graphical Illustration

= Indicates Toxic to aquatic organisms specially fishes.

specially fishes. After confluence of the River Diyung with Kopili at Station 7, the water quality parameters found to be restored towards congenial range for fishes. This restored habitat from Station 7 onwards should be managed and conserved in consultation with professionals. There is variation of 0.24 m to 0.37 m either decrease (during lean period) or increase (during monsoon) in the confluence of Amring river to Diyung River in post dam period.

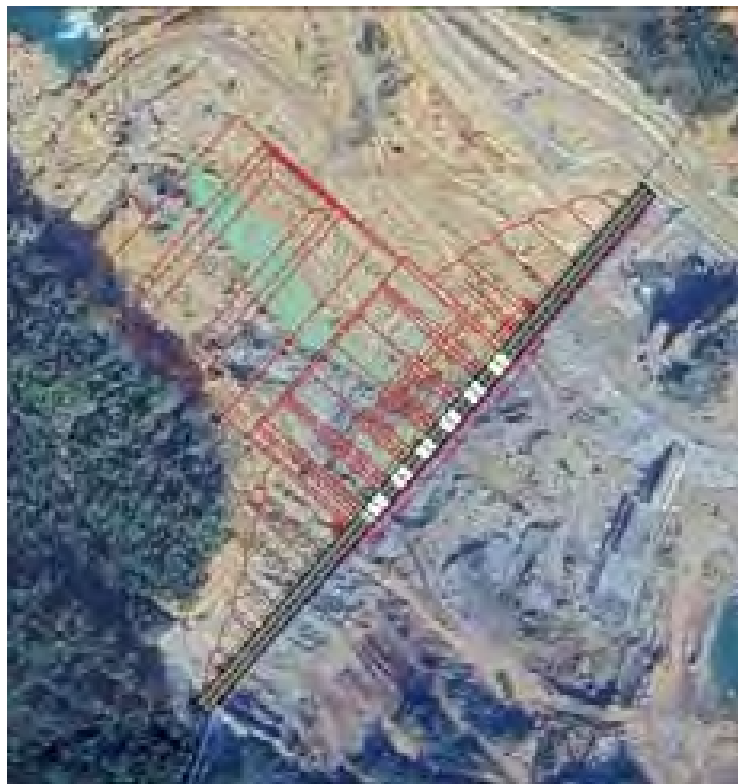
Map 43: Digitised Dam Structure Model

224. The Lower Kopili Dam is a concrete dam with a spillway having six gates and seven bays. The dam also has a gate for debris flow. In concrete dams, the primary causes of failure are mainly through overtopping. Therefore, this study considers the overtopping failure mode. The flood modelling was conducted for PMF, SPF, and 100-year flow conditions, assuming that the reservoir is at FRL before the inflow of floodwaters into the reservoir. Additionally, the analysis included a scenario without any flood conditions (fair weather failure) when the water level is at FRL, with a constant river flow of 113.2 cumecs. To assess the dam's safety against the PMF, the PMF was allowed to pass through the gate keeping all gates open. The following table details the scenarios that were considered for further analysis:

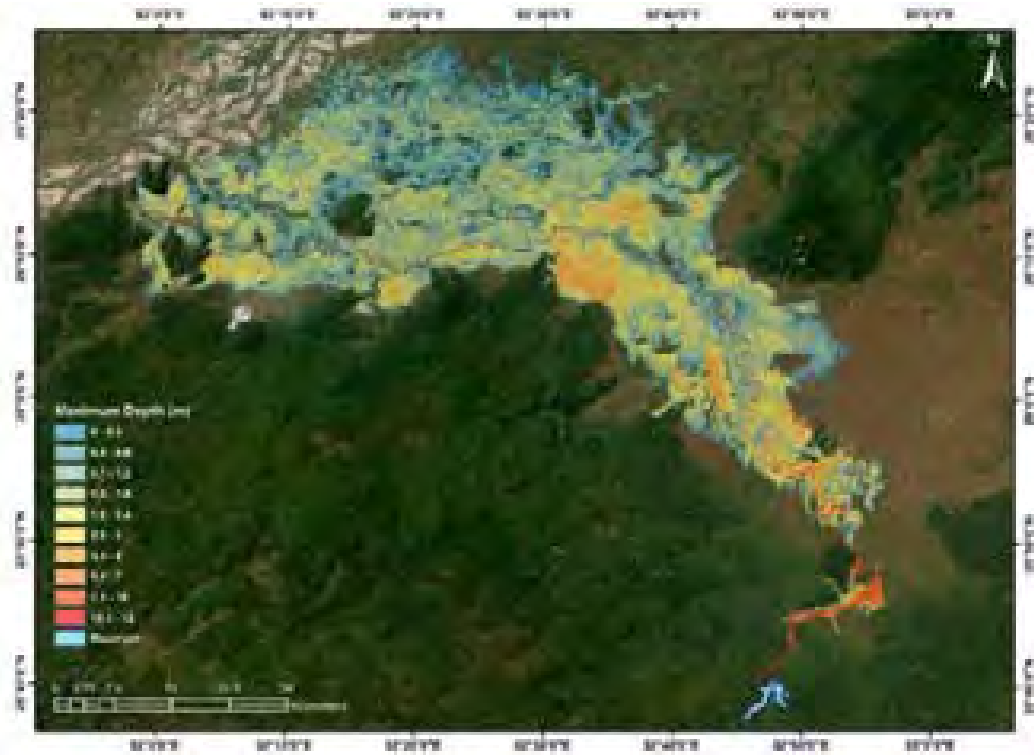
Map 44: Maximum depth (flood inundation) map (PMF)

230. In this scenario, a forced failure of the dam is analysed when PMF impinges. It is assumed that all gates are kept fully closed during the event, and the critical depth of 0.6 meters above the dam crest triggers overtopping failure. A hydrograph near the confluence points of Kopili with different rivers downstream of the dam is obtained.

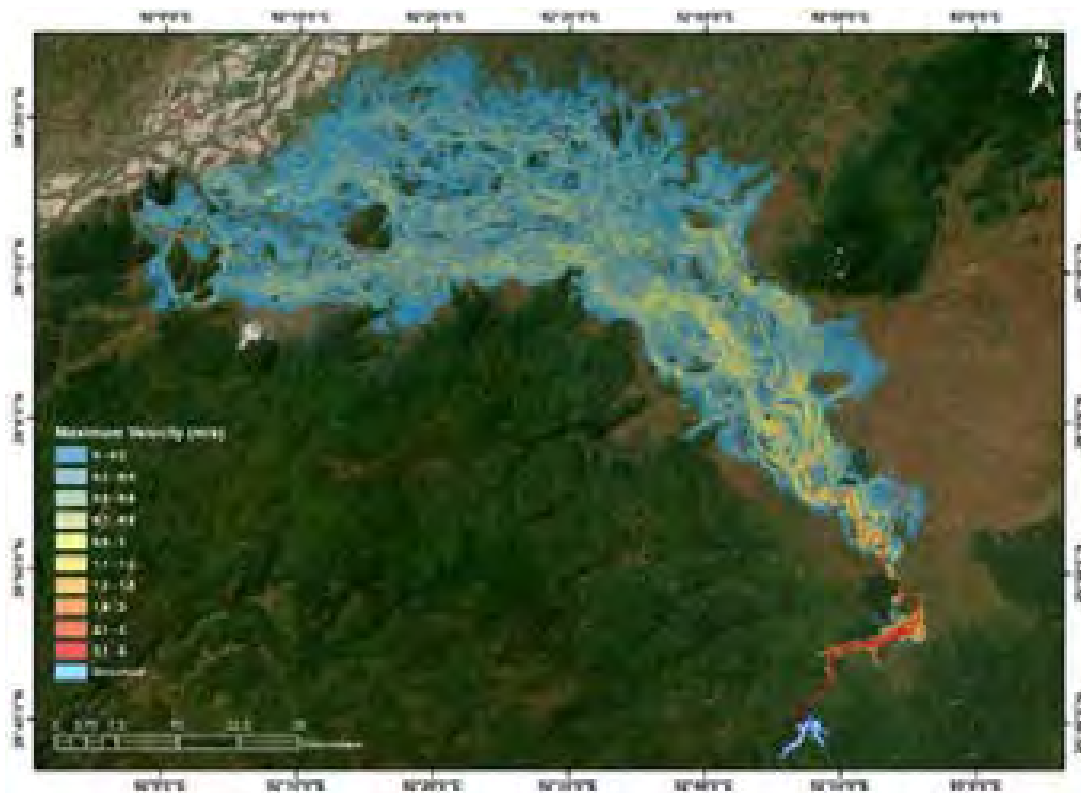
Map 45: Maximum velocity (flood inundation) map (PMF)

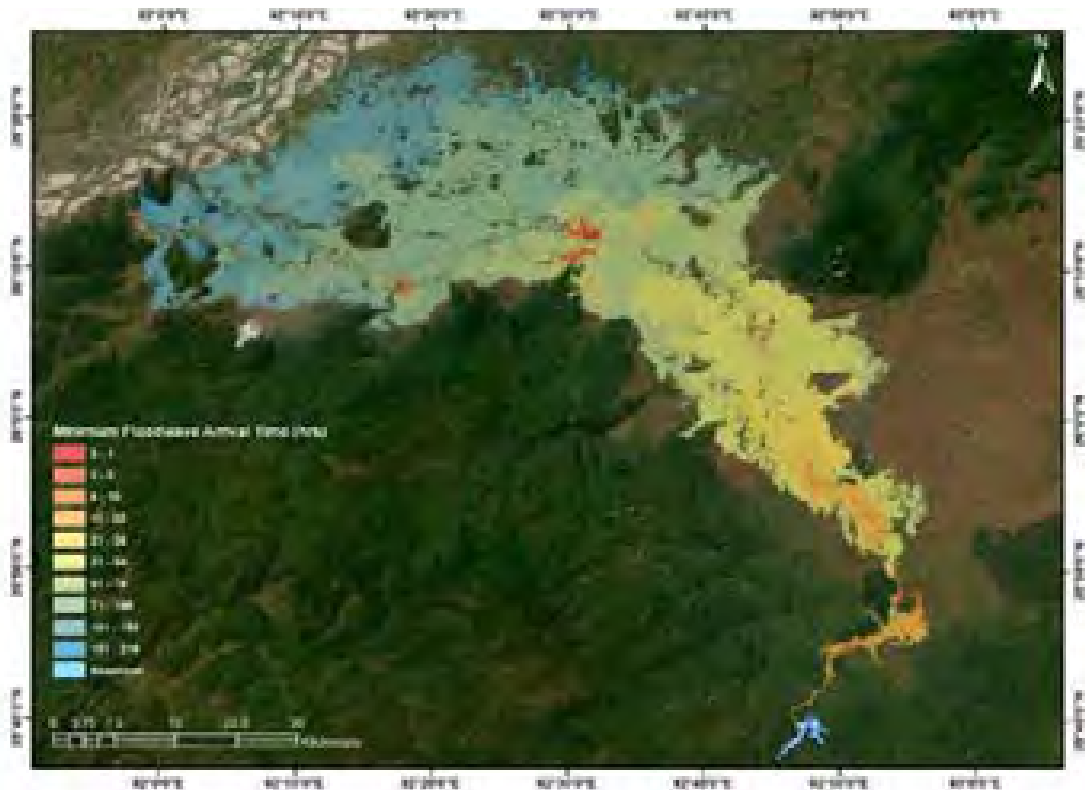
Map 46: Minimum flood wave arrival time in the inundated area (PMF)

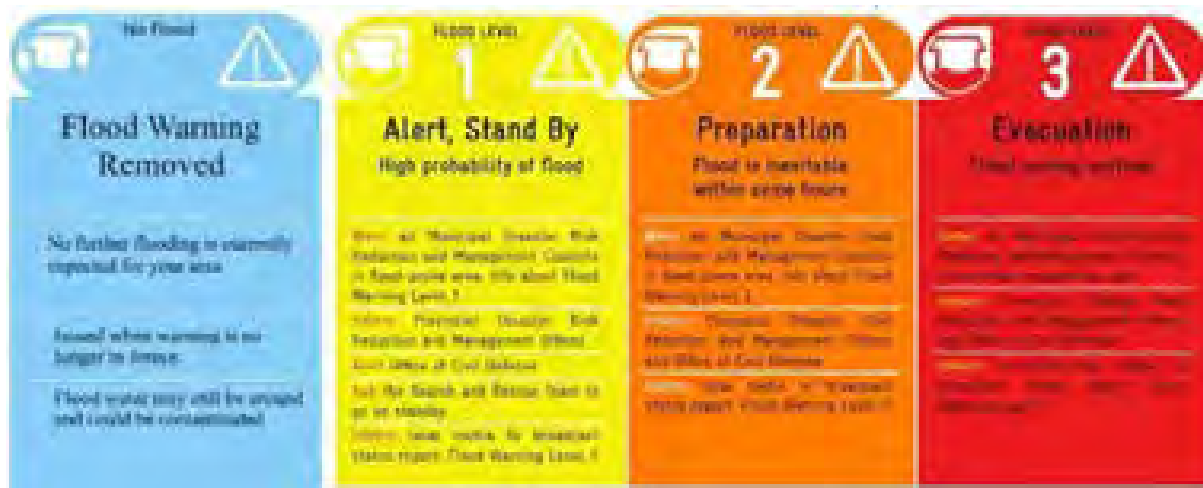
Figure 60: Color-coded flood alert and warning

310. The warning information will be generated and send in the form of SMS and flood bulletin to registered users. Flood early warnings will follow the stand color code followed by IMD/WMO as show in Figure 60.

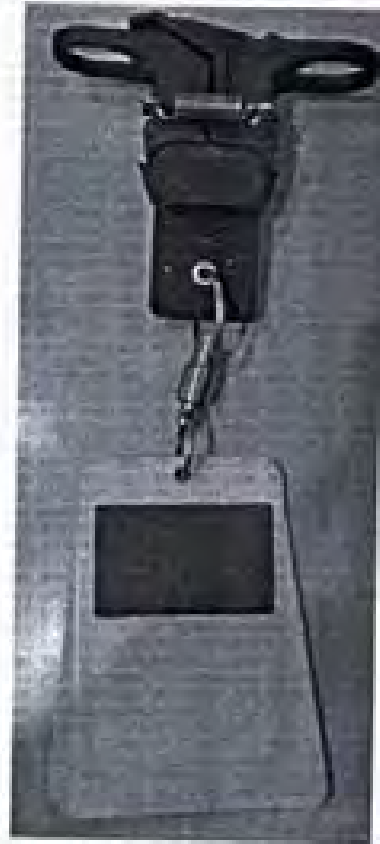
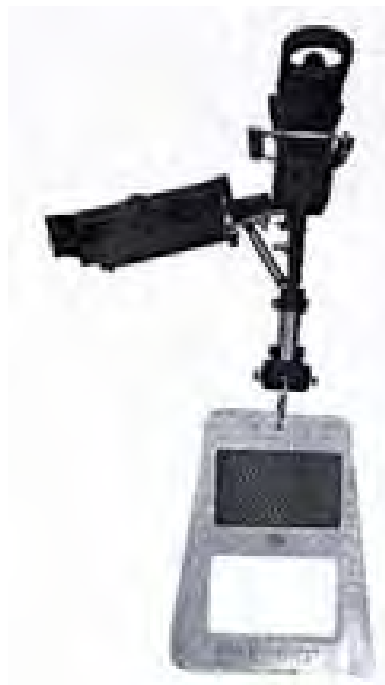
Figure 1: Types of Bird Flight Divertors
(approved for other projects in the Region)

5. Sample Bird Flight Divertor approved for the similar transmission line in Northeast India are shown in the figure 1 with technical specification in figure 2.

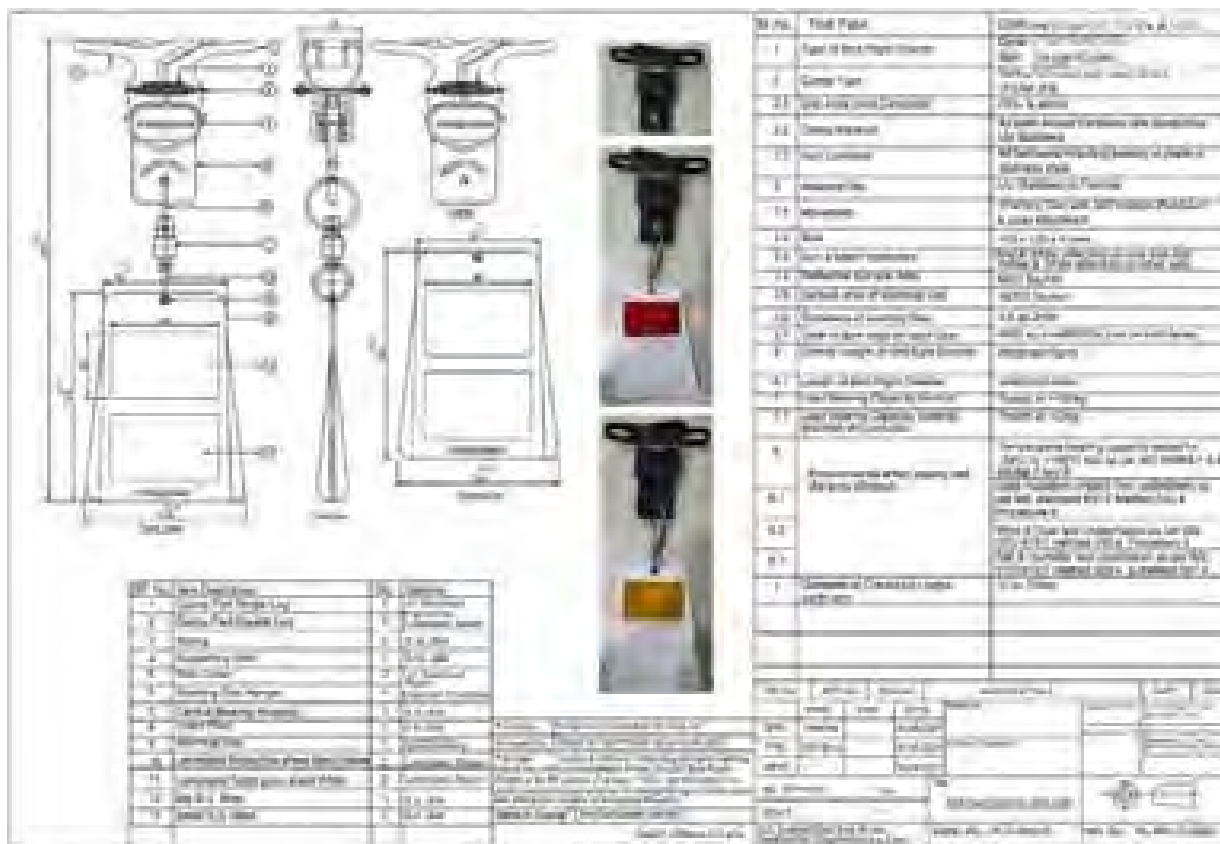
Figure 2: Technical specification of the sample BFD
